Manhole Inspection Summary

Manhole # S47C__014MH

Insp Date: **7/15/08 8:38 AM**

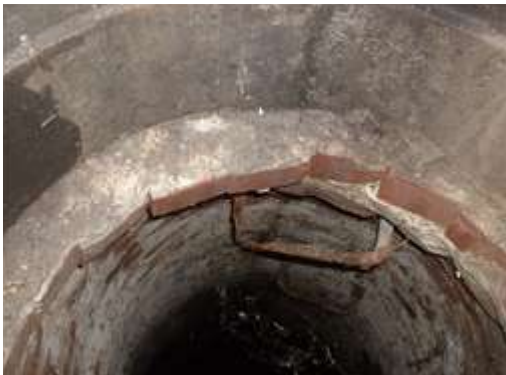
Defect 1

Infiltration: ☐ None ☐ Joint ☐ Cracks ☒ **Mortar** ☐ Roots ☐ Wall

infiltration

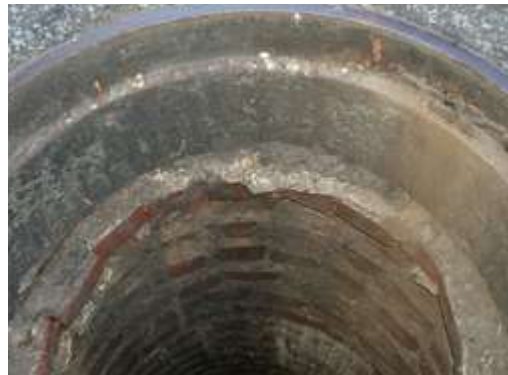
Defect 2

frame leaks

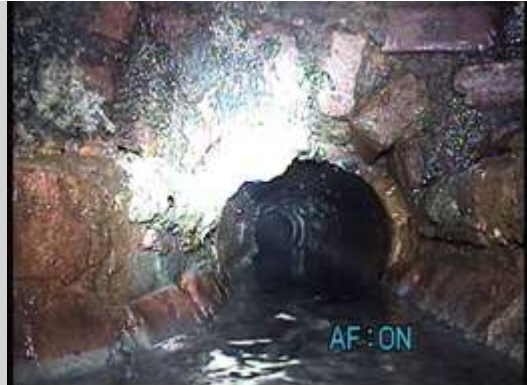
12 O'Clock Outflow

Pipe Height: **8.4** (in.) Rod and Bar (Angled)
Pipe Material: **Clay** ☐ Pipe Lined
Invert Depth: **13.80** (ft.) Flow Characteristics: **Fast**
Deposits: ☒ None ☐ Mud ☐ Sludge ☐ Debris ☐ Grease
Silt Depth: (in.) Deposits Extent:
Infiltration: **None** Pipe Seal Cond: **Sound**

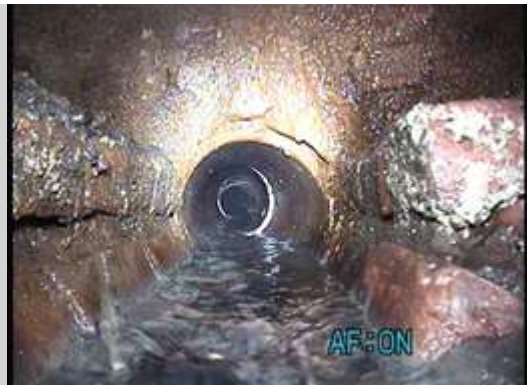
6 O'Clock Inflow

Pipe Height: **8.4** (in.) Rod and Bar (Angled)
Pipe Material: **Clay** ☐ Pipe Lined
Invert Depth: **13.75** (ft.) Flow Characteristics: **Fast**
Deposits: ☒ None ☐ Mud ☐ Sludge ☐ Debris ☐ Grease
Silt Depth: (in.) Deposits Extent:
Infiltration: **None** Pipe Seal Cond: **Sound**

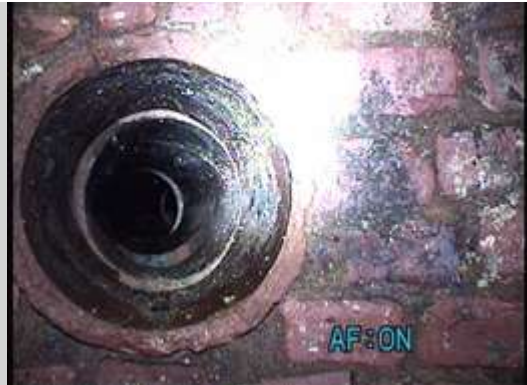
9 O'Clock Inflow

Pipe Height: **8.4** (in.) Rod and Bar (Angled)

Infiltration: **None** Pipe Seal Cond: **Sound**

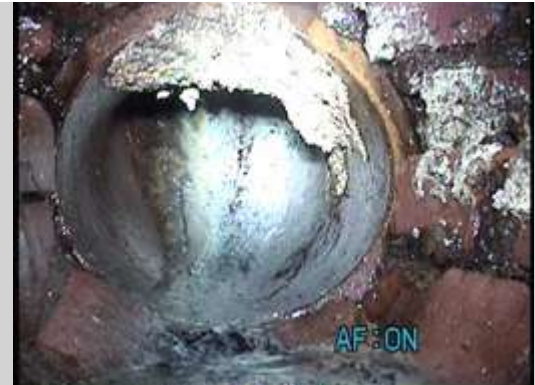
Drop In @ 9 O'Clock

Drop: **Inside**

Drop Condition: **Open**
